REMOVAL REPORT
FOR
DIAZ INTERMEDIATES CORPORATION SITE
301 WYANOKE ROAD
WEST MEMPHIS, CRITTENDEN COUNTY, ARKANSAS

**REMOVAL ASSESSMENT REPORT
FOR
DIAZ INTERMEDIATES CORPORATION SITE

301 WYANOKE ROAD
WEST MEMPHIS, CRITTENDEN COUNTY, ARKANSAS**

Date Prepared:
October 27, 2008

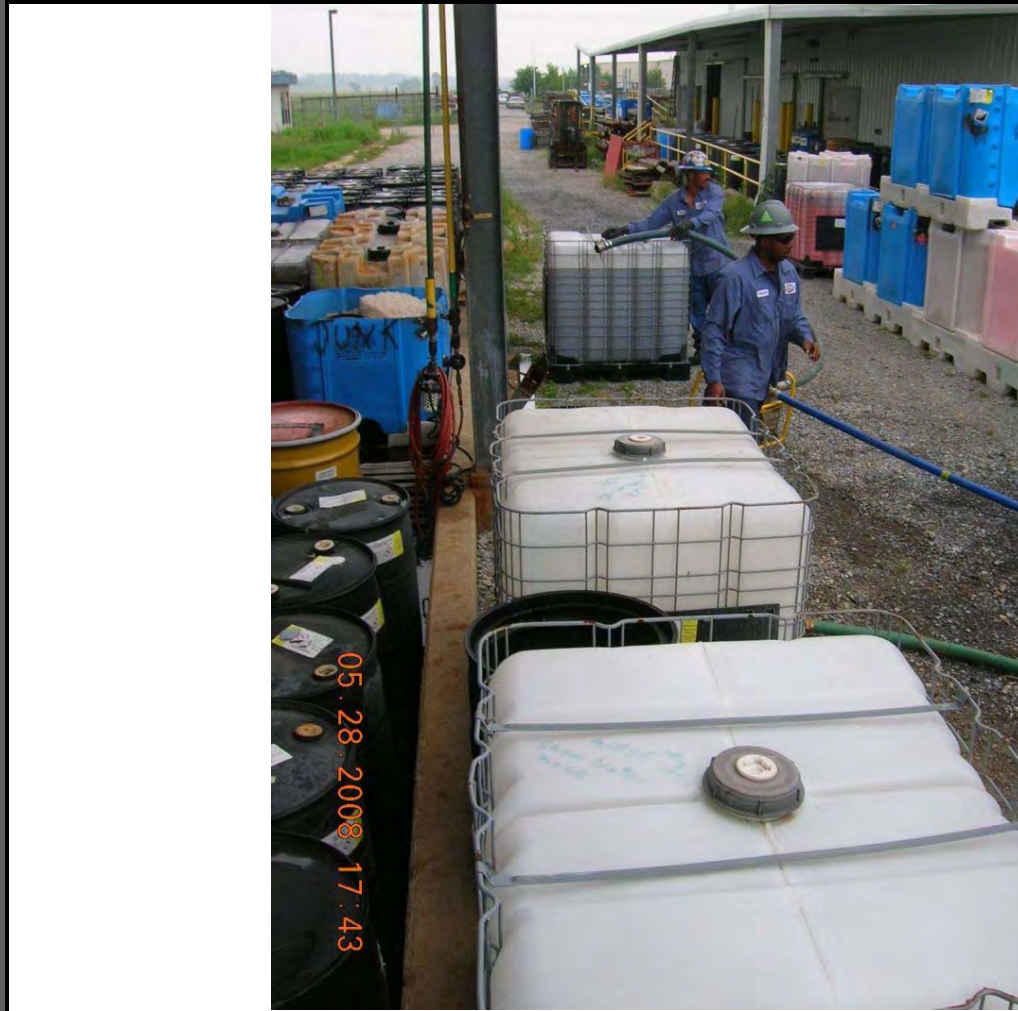
Logbook Photo #	108
US EPA ID / Task Order Number	ARR000005843 / TO-0001-08-01-01
Site	Diaz Intermediates Corporation
Location Address	301 Wyanoke Road
City, State, ZIP code	West Memphis, Arkansas 72301
County	Crittenden
Direction/Orientation	North
Date	05/28/08
Time	1741
Photographer	Troy Naquin, Dynamac START-3
Witness	NA
Description:	View of Drum Pad containment area after pumping out the pooled storm water.

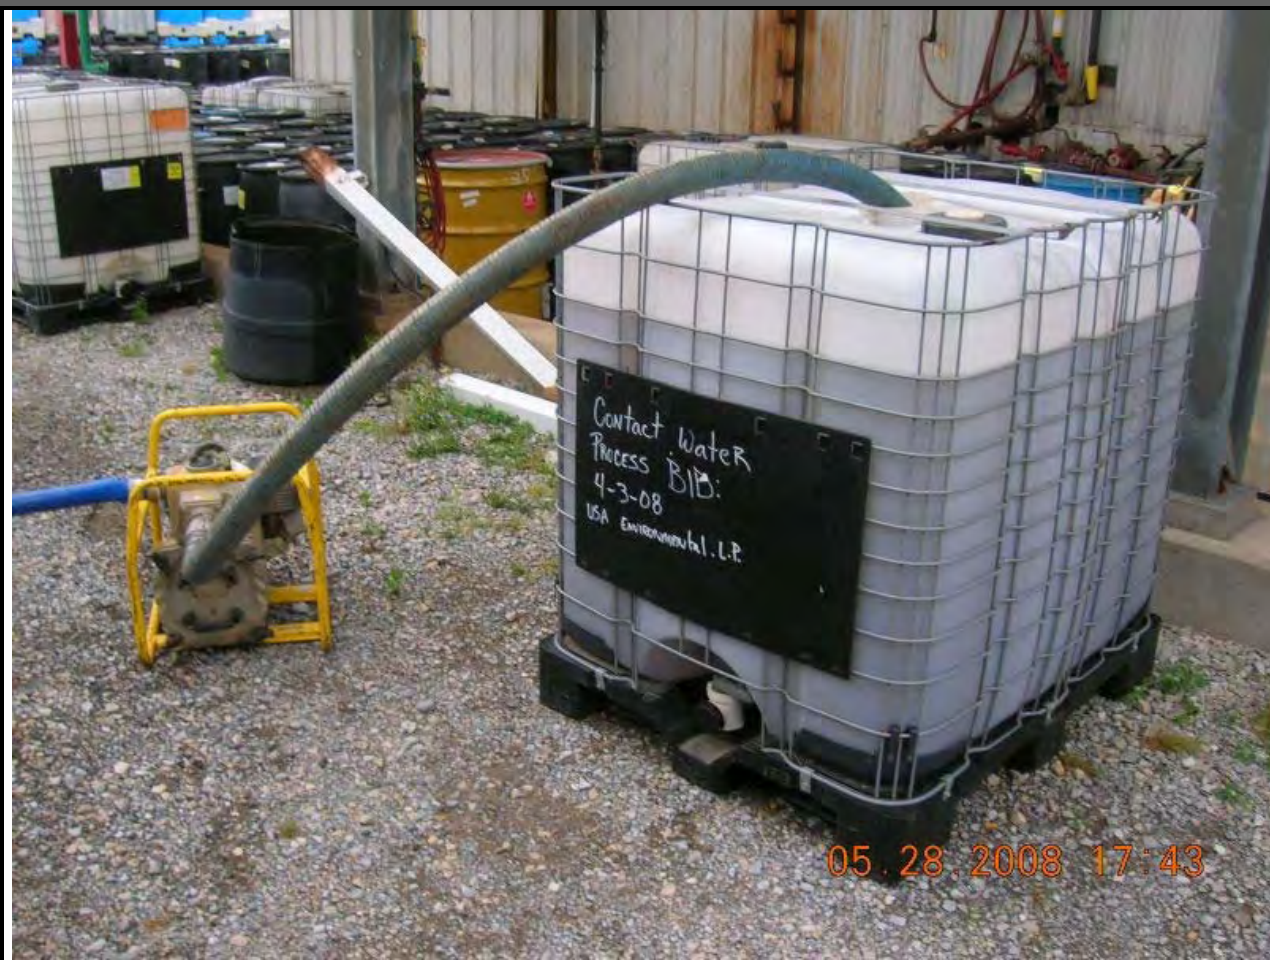
Logbook Photo #	109
US EPA ID / Task Order Number	ARR000005843 / TO-0001-08-01-01
Site	Diaz Intermediates Corporation
Location Address	301 Wyanoke Road
City, State, ZIP code	West Memphis, Arkansas 72301
County	Crittenden
Direction/Orientation	South
Date	05/28/08
Time	1743
Photographer	Troy Naquin, Dynamac START-3
Witness	NA
Description: Pumping out of tote tanks containing Warehouse storm water from 4/1/08 and contact storm water from Process Area.

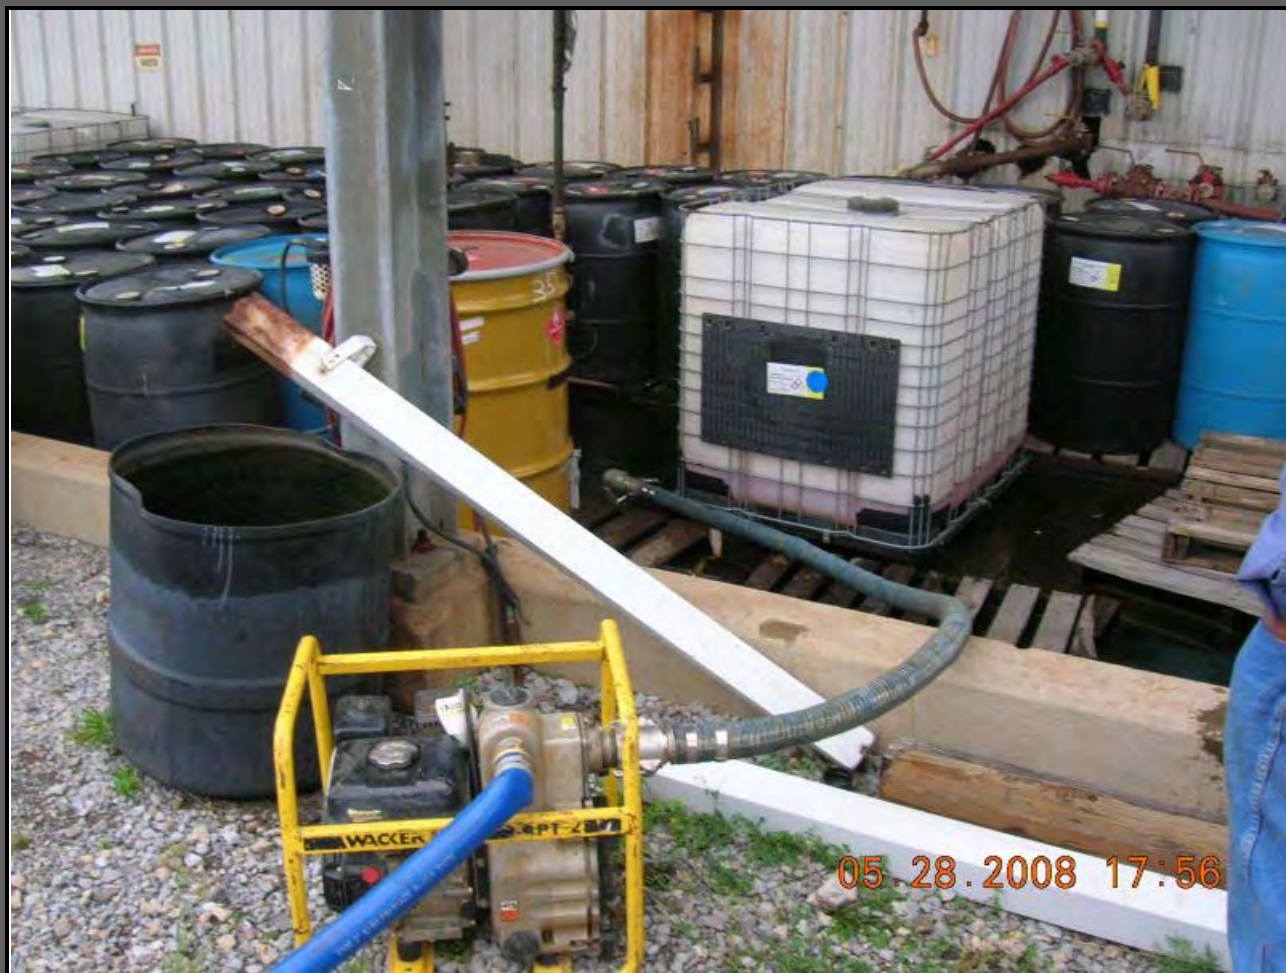
Logbook Photo #	110
US EPA ID / Task Order Number	ARR000005843 / TO-0001-08-01-01
Site	Diaz Intermediates Corporation
Location Address	301 Wyanoke Road
City, State, ZIP code	West Memphis, Arkansas 72301
County	Crittenden
Direction/Orientation	Northeast
Date	05/28/08
Time	1743
Photographer	Troy Naquin, Dynamac START-3
Witness	NA
Description: Pumping out of tote tank containing Process Area contact water from 4/3/08 into Old Tank Farm secondary containment area then into sanitary sewer.

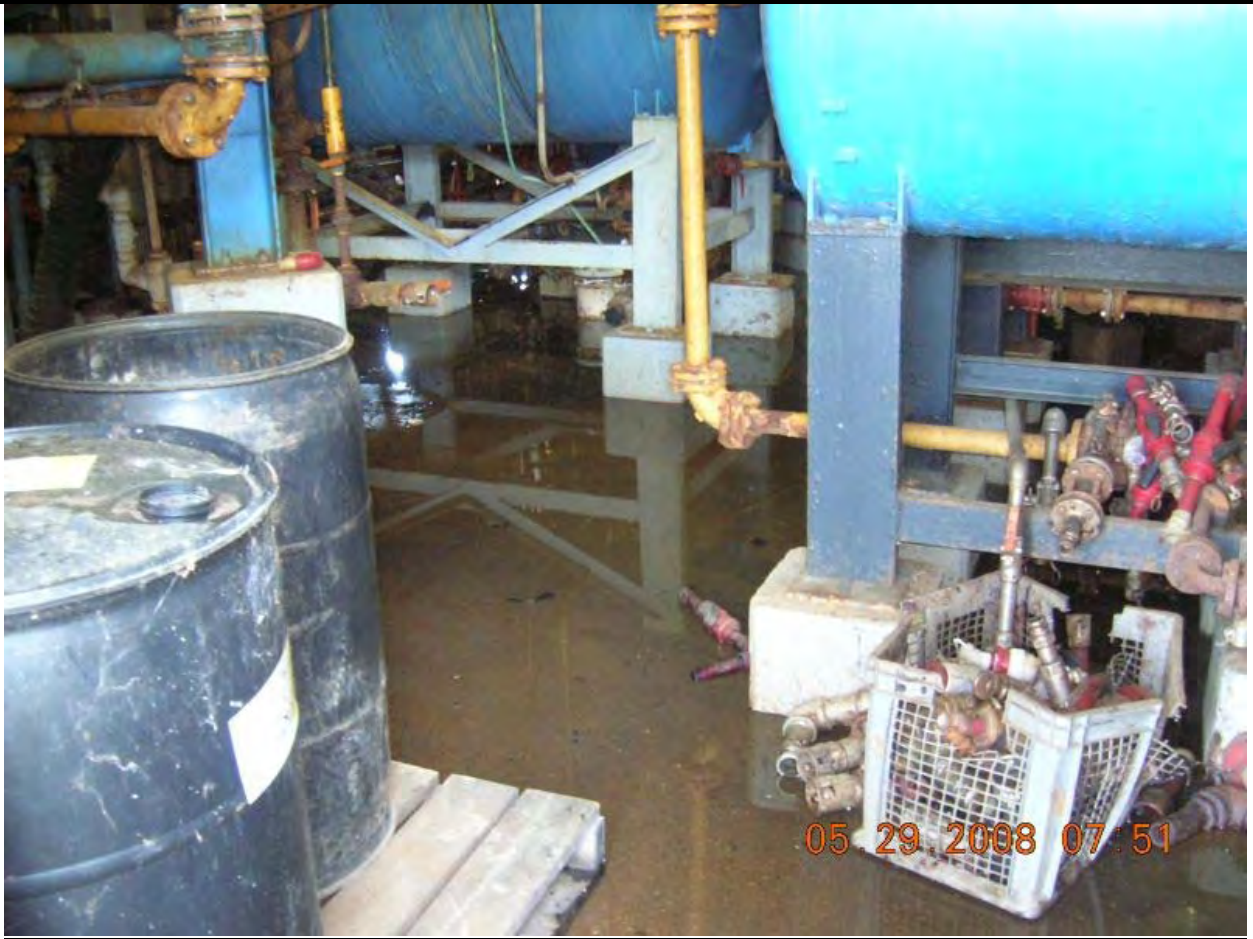
Logbook Photo #	114
US EPA ID / Task Order Number	ARR000005843 / TO-0001-08-01-01
Site	Diaz Intermediates Corporation
Location Address	301 Wyanoke Road
City, State, ZIP code	West Memphis, Arkansas 72301
County	Crittenden
Direction/Orientation	Southeast
Date	05/29/08
Time	0742
Photographer	Troy Naquin, Dynamac START-3
Witness	NA
Description:	Pumping pooled storm water in Process Area into the Old Tank Farm secondary containment area then into sanitary sewer.

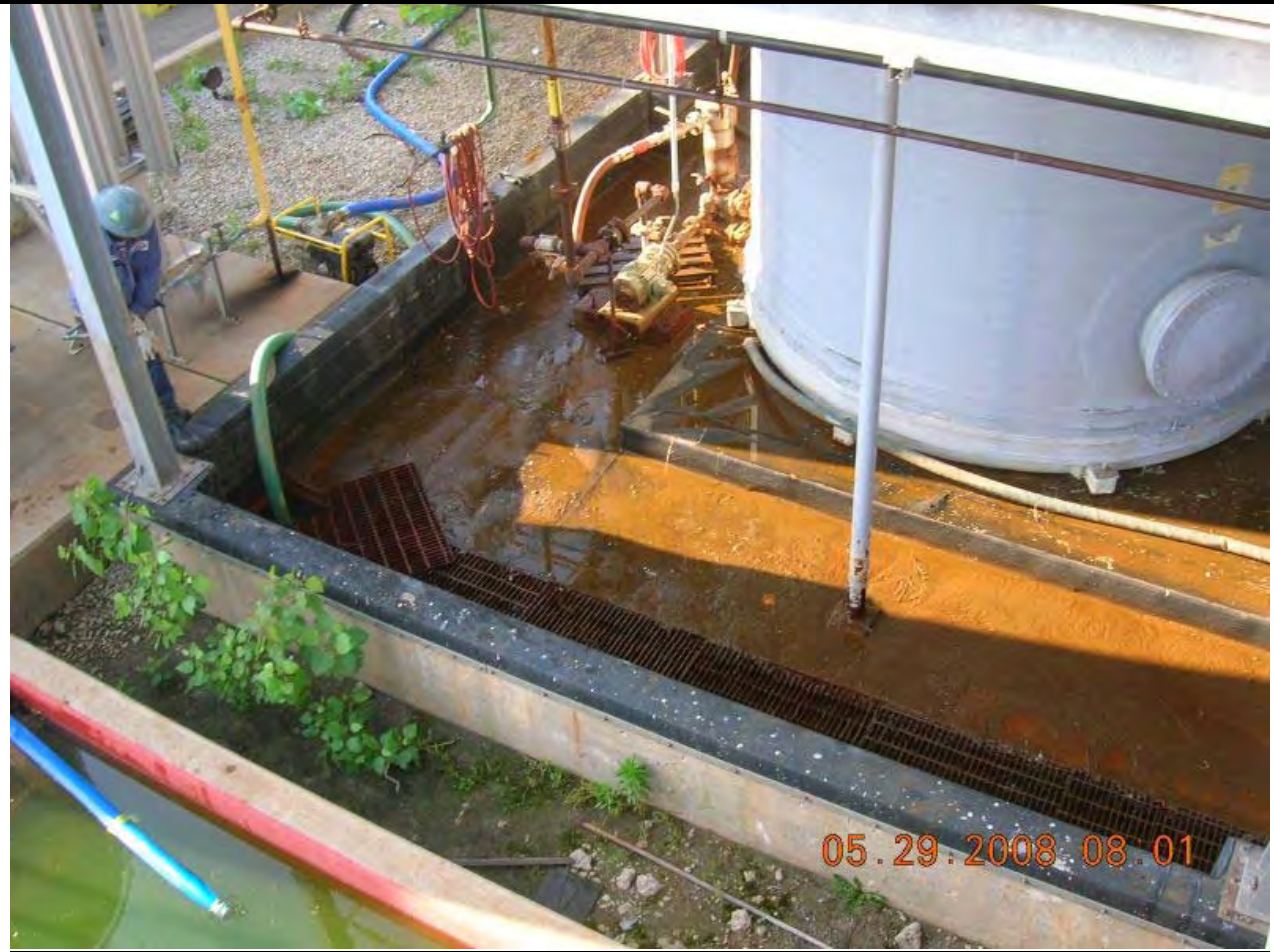
Logbook Photo #	116
US EPA ID / Task Order Number	ARR000005843 / TO-0001-08-01-01
Site	Diaz Intermediates Corporation
Location Address	301 Wyanoke Road
City, State, ZIP code	West Memphis, Arkansas 72301
County	Crittenden
Direction/Orientation	Down
Date	05/29/08
Time	0800
Photographer	Troy Naquin, Dynamac START-3
Witness	NA
Description: View of the Old Tank Farm secondary containment area after the pooled storm water was pumped out into the sanitary sewer.

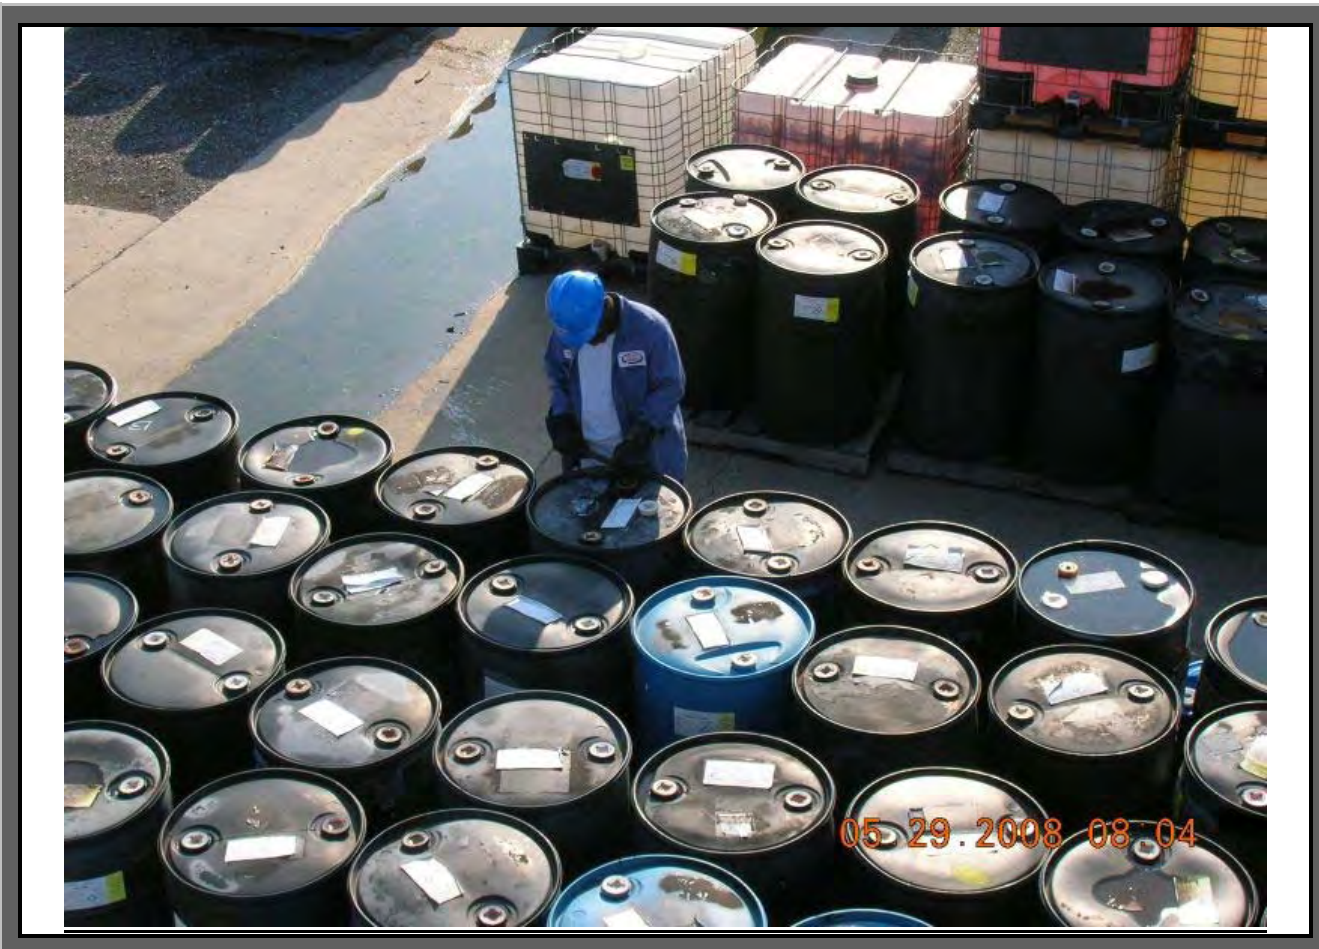
Logbook Photo #	117
US EPA ID / Task Order Number	ARR000005843 / TO-0001-08-01-01
Site	Diaz Intermediates Corporation
Location Address	301 Wyanoke Road
City, State, ZIP code	West Memphis, Arkansas 72301
County	Crittenden
Direction/Orientation	Down
Date	05/29/08
Time	0801
Photographer	Troy Naquin, Dynamac START-3
Witness	NA
Description: View of the Old Tank Farm secondary containment area after the pooled storm water was pumped out into the sanitary sewer.

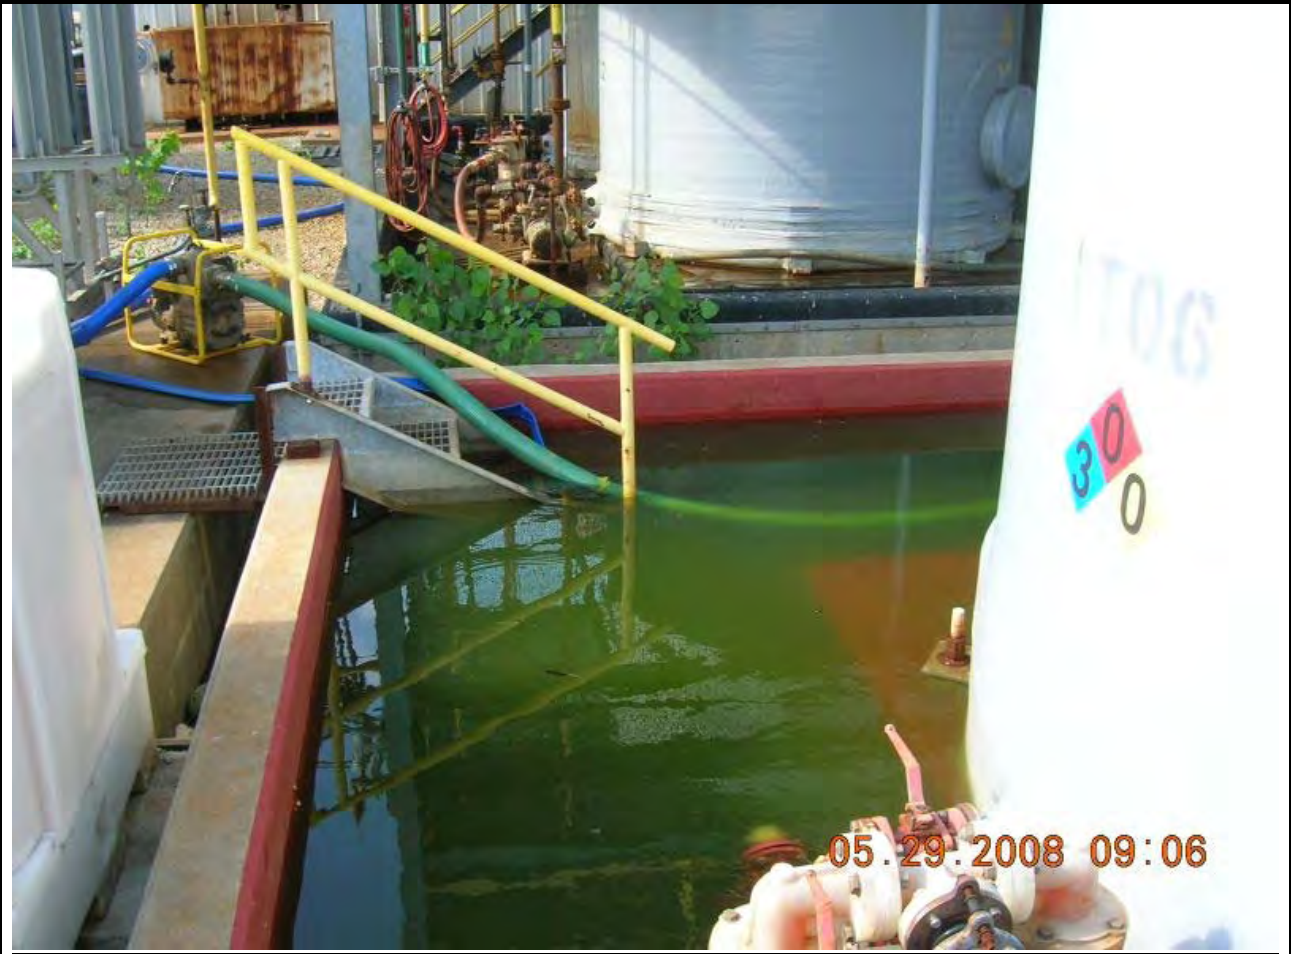
Logbook Photo #	118
US EPA ID / Task Order Number	ARR000005843 / TO-0001-08-01-01
Site	Diaz Intermediates Corporation
Location Address	301 Wyanoke Road
City, State, ZIP code	West Memphis, Arkansas 72301
County	Crittenden
Direction/Orientation	Down
Date	05/29/08
Time	0804
Photographer	Troy Naquin, Dynamac START-3
Witness	NA
Description: ERRS securing drum bungs.

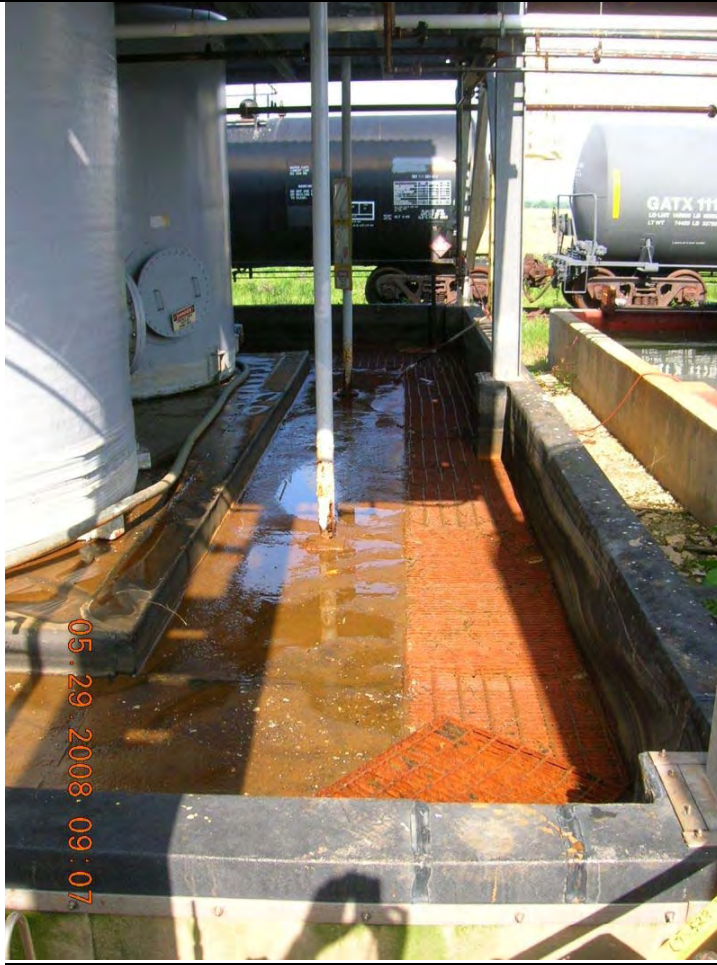
Logbook Photo #	119
US EPA ID / Task Order Number	ARR000005843 / TO-0001-08-01-01
Site	Diaz Intermediates Corporation
Location Address	301 Wyanoke Road
City, State, ZIP code	West Memphis, Arkansas 72301
County	Crittenden
Direction/Orientation	South
Date	05/29/08
Time	0906
Photographer	Troy Naquin, Dynamac START-3
Witness	NA
Description: Pumping out pooled storm water from the New Tank Farm secondary containment area into the sanitary sewer.

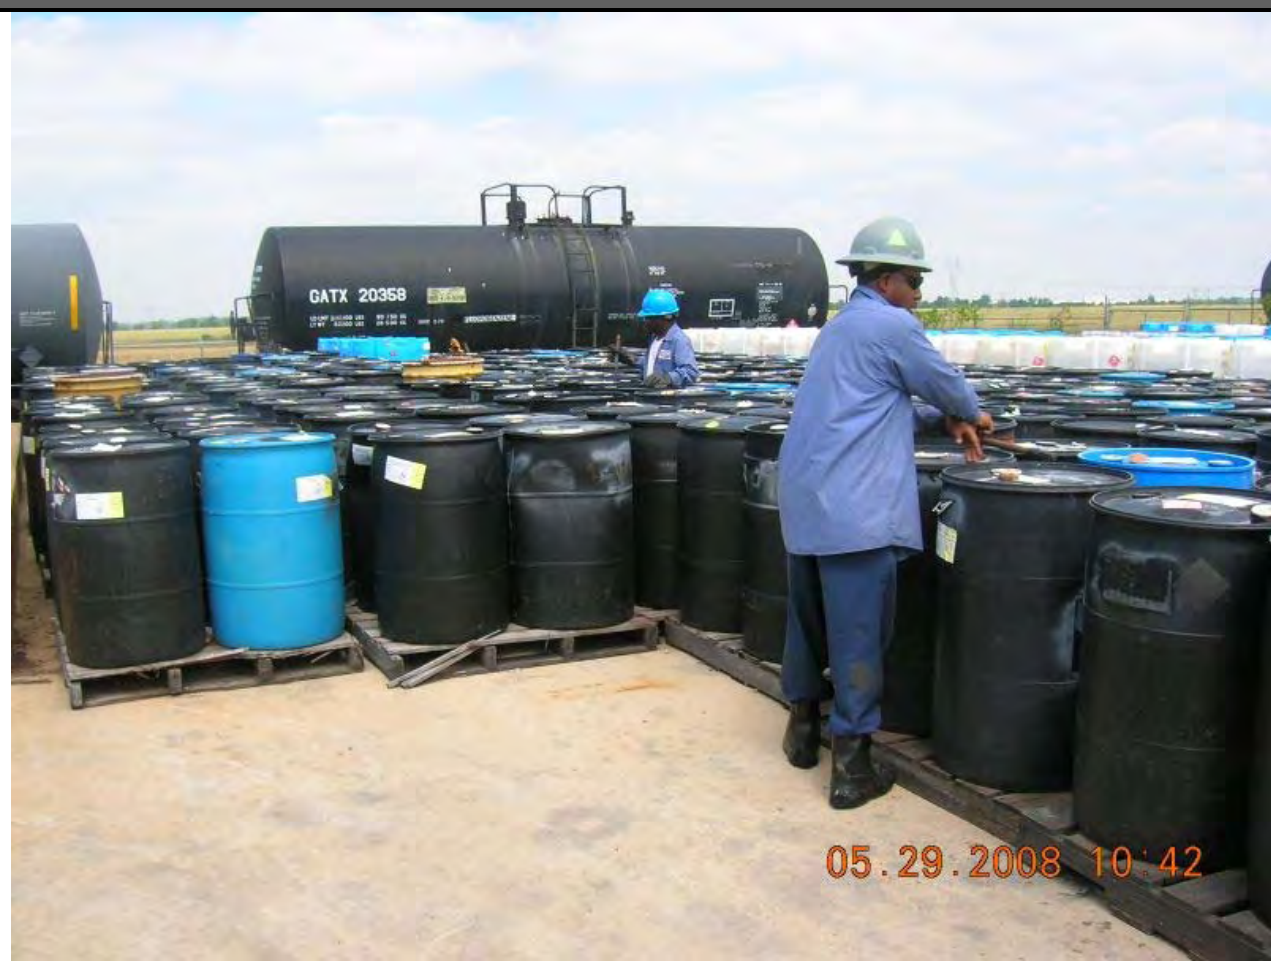
Logbook Photo #	123
US EPA ID / Task Order Number	ARR000005843 / TO-0001-08-01-01
Site	Diaz Intermediates Corporation
Location Address	301 Wyanoke Road
City, State, ZIP code	West Memphis, Arkansas 72301
County	Crittenden
Direction/Orientation	Northwest
Date	05/29/08
Time	1042
Photographer	Troy Naquin, Dynamac START-3
Witness	NA
Description: ERRS changing out drum bungs on containers staged in the Drum Pad area.

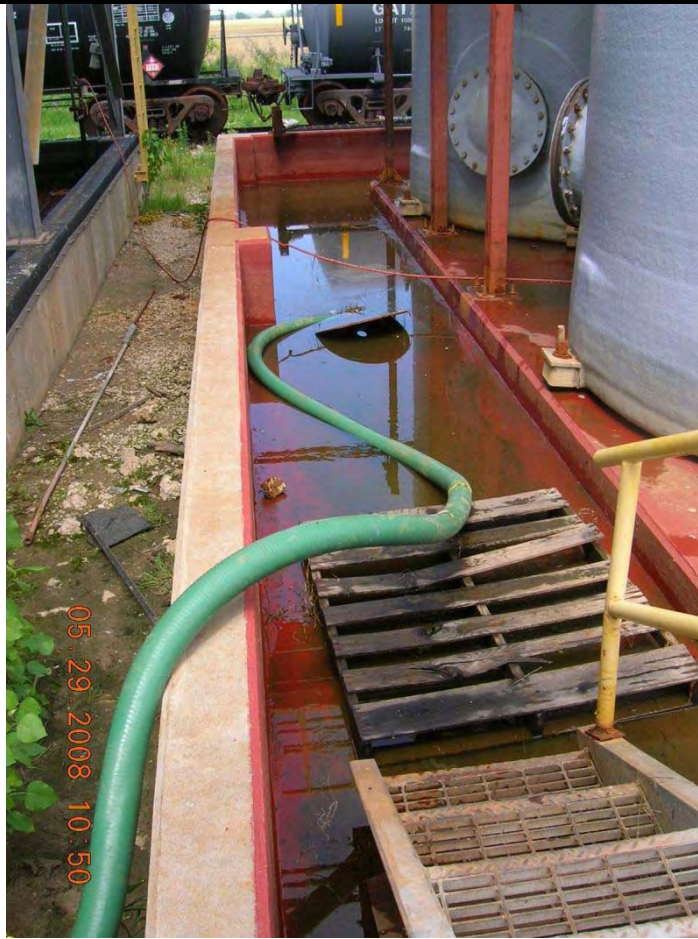
Logbook Photo #	124
US EPA ID / Task Order Number	ARR000005843 / TO-0001-08-01-01
Site	Diaz Intermediates Corporation
Location Address	301 Wyanoke Road
City, State, ZIP code	West Memphis, Arkansas 72301
County	Crittenden
Direction/Orientation	West
Date	05/29/08
Time	1050
Photographer	Troy Naquin, Dynamac START-3
Witness	NA
Description:	View of the New Tank Farm secondary containment area after the pooled storm water was pumped out.

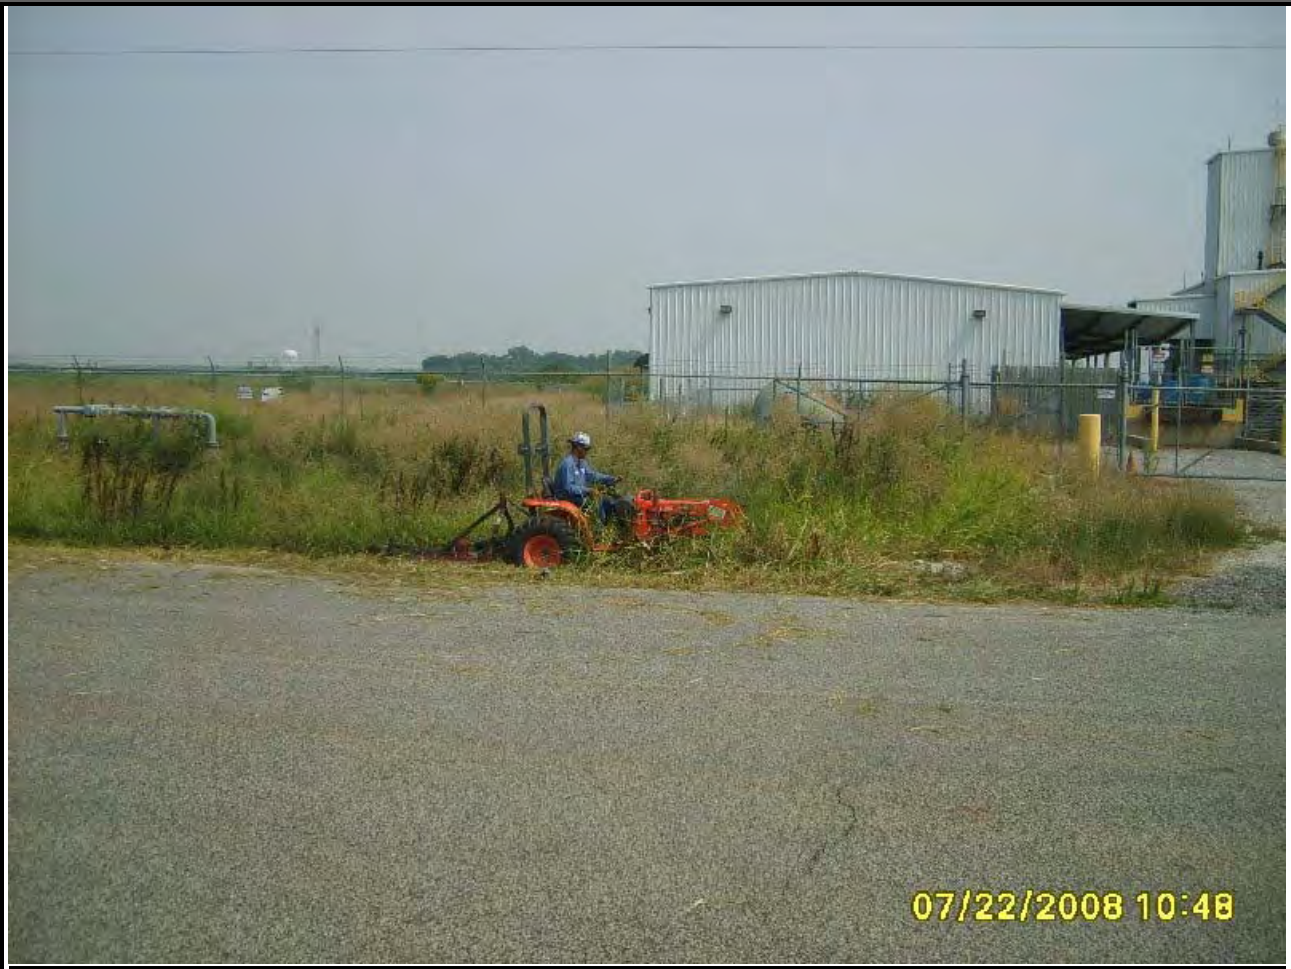
Logbook Photo #	125
US EPA ID / Task Order Number	ARR000005843 / TO-0001-08-01-01
Site	Diaz Intermediates Corporation
Location Address	301 Wyanoke Road
City, State, ZIP code	West Memphis, Arkansas 72301
County	Crittenden
Direction/Orientation	North - Northwest
Date	07/22/08
Time	1048
Photographer	Steve Cowan, Dynamac START-3
Witness	NA
Description: ERRS cutting grass along front drainage ditch at site.

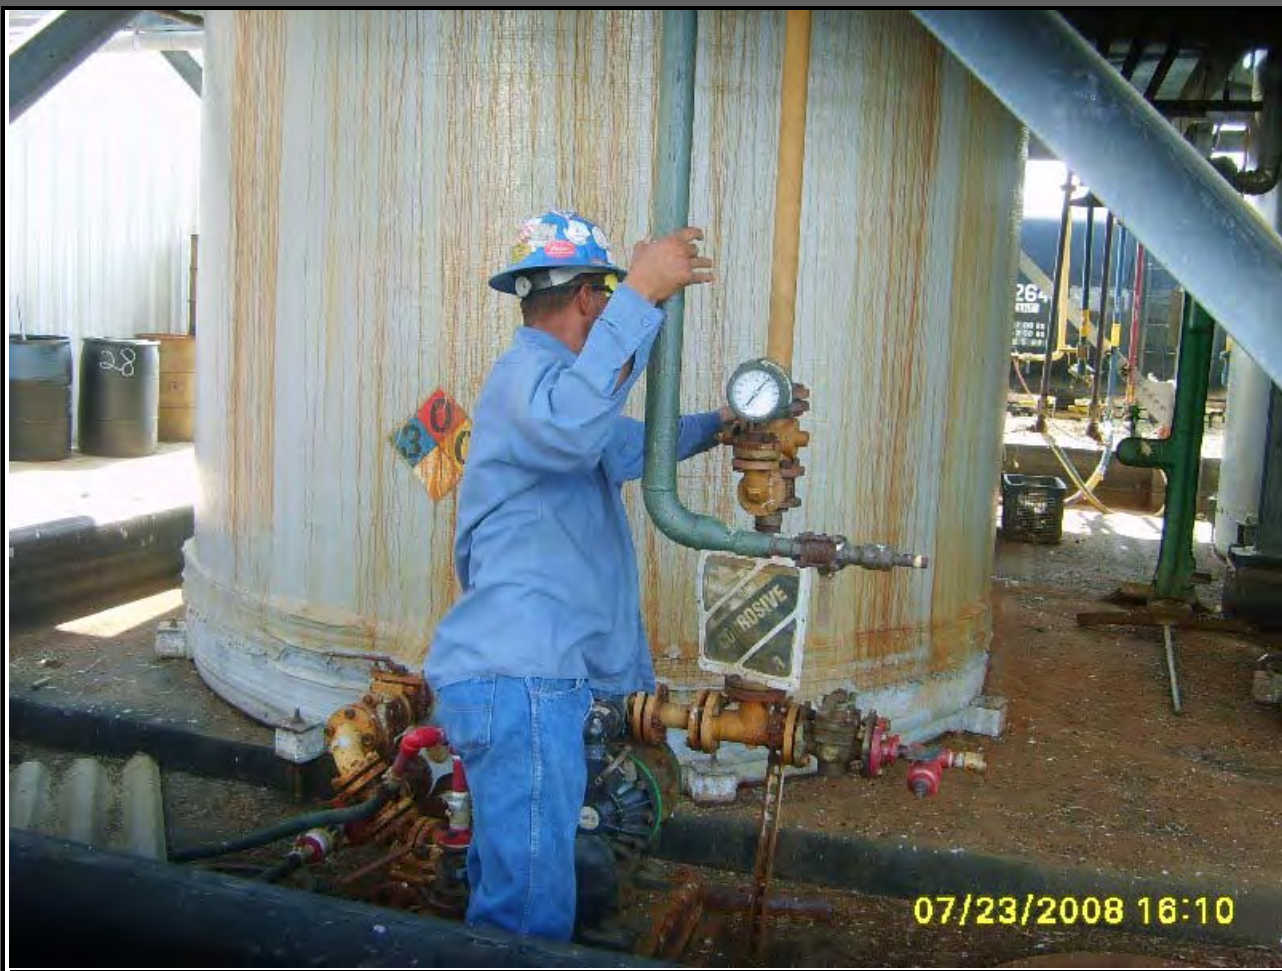
Logbook Photo #	126
US EPA ID / Task Order Number	ARR000005843 / TO-0001-08-01-01
Site	Diaz Intermediates Corporation
Location Address	301 Wyanoke Road
City, State, ZIP code	West Memphis, Arkansas 72301
County	Crittenden
Direction/Orientation	West
Date	07/23/08
Time	1610
Photographer	Steve Cowan, Dynamac START-3
Witness	NA
Description: ERRS opening valve on AST IT-04 to release pressure inside the tank.

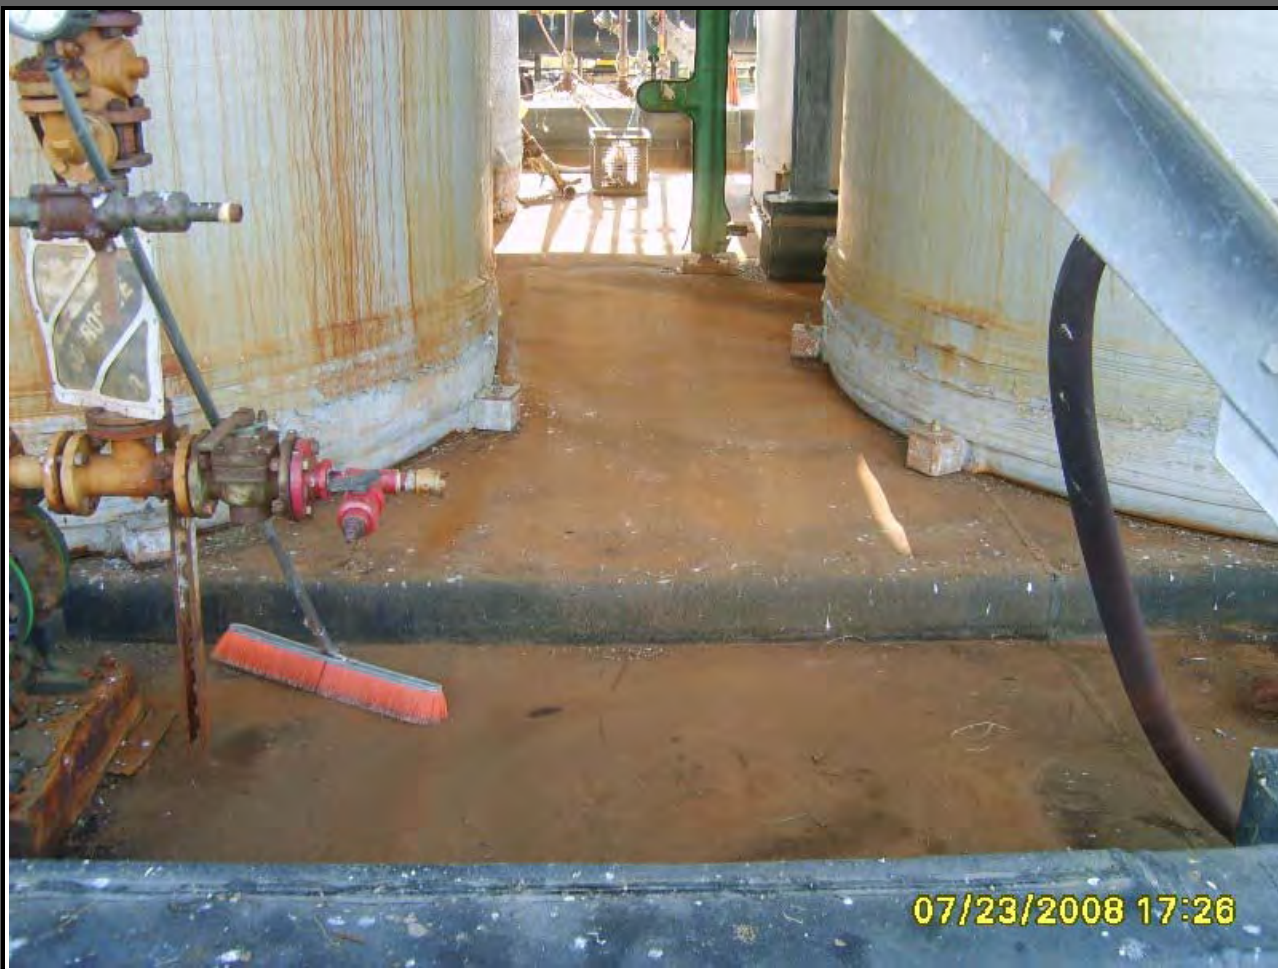
Logbook Photo #	127
US EPA ID / Task Order Number	ARR000005843 / TO-0001-08-01-01
Site	Diaz Intermediates Corporation
Location Address	301 Wyanoke Road
City, State, ZIP code	West Memphis, Arkansas 72301
County	Crittenden
Direction/Orientation	West
Date	07/23/08
Time	1726
Photographer	Steve Cowan, Dynamac START-3
Witness	NA
Description:	View of the cleaned secondary containment area in the Old Tank Farm.

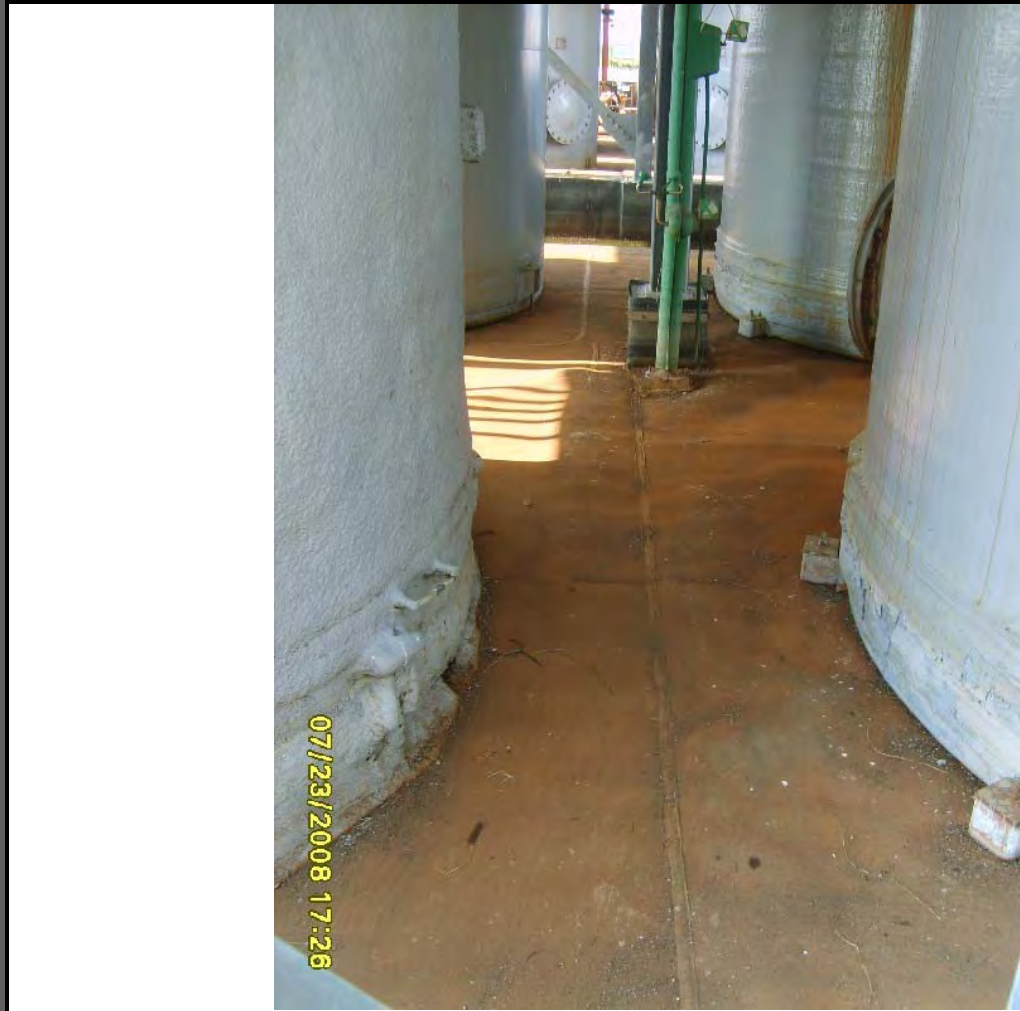
Logbook Photo #	128
US EPA ID / Task Order Number	ARR000005843 / TO-0001-08-01-01
Site	Diaz Intermediates Corporation
Location Address	301 Wyanoke Road
City, State, ZIP code	West Memphis, Arkansas 72301
County	Crittenden
Direction/Orientation	North
Date	07/23/08
Time	1726
Photographer	Steve Cowan, Dynamac START-3
Witness	NA
Description: Another view of the cleaned secondary containment area in the Old Tank Farm.

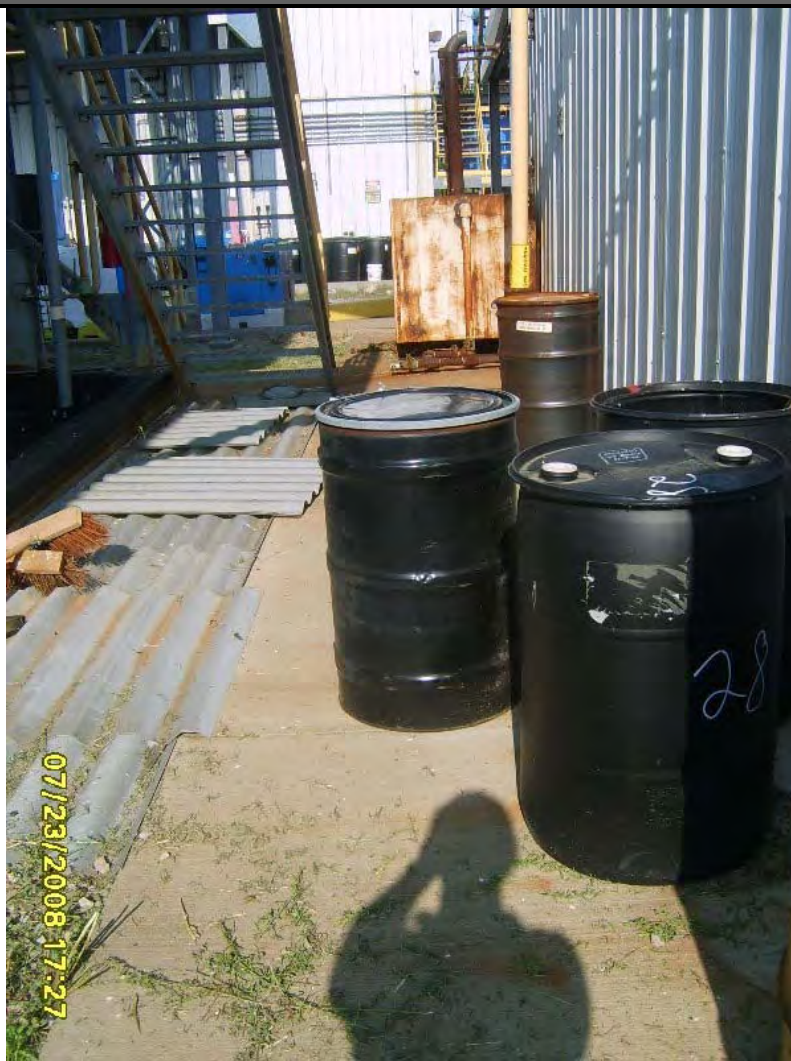
Logbook Photo #	129
US EPA ID / Task Order Number	ARR000005843 / TO-0001-08-01-01
Site	Diaz Intermediates Corporation
Location Address	301 Wyanoke Road
City, State, ZIP code	West Memphis, Arkansas 72301
County	Crittenden
Direction/Orientation	East
Date	07/23/08
Time	1727
Photographer	Steve Cowan, Dynamac START-3
Witness	NA
Description: View of drums containing floor sweep from the Old Tank Farm secondary containment area.

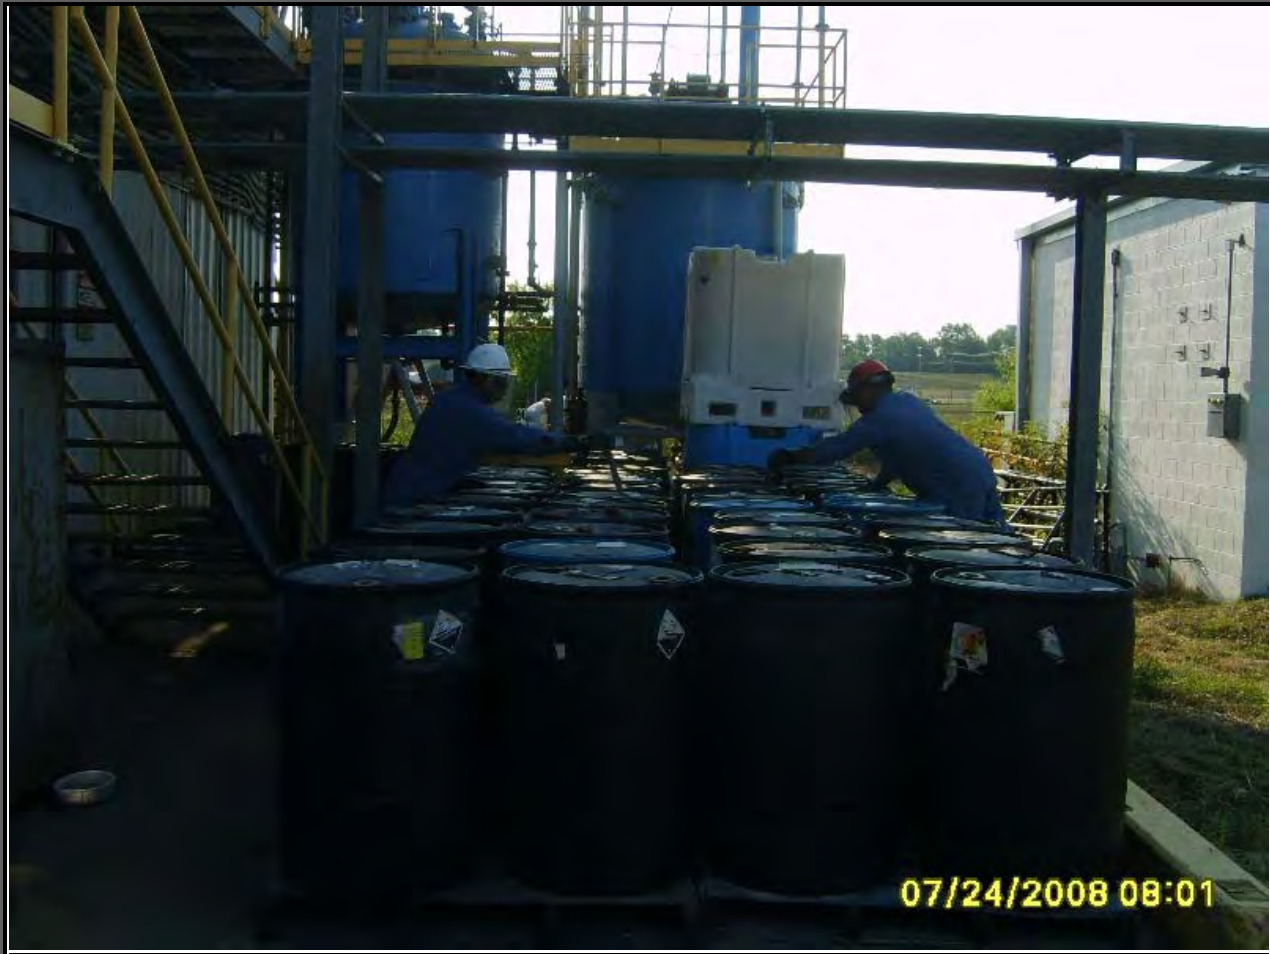
Logbook Photo #	130
US EPA ID / Task Order Number	ARR000005843 / TO-0001-08-01-01
Site	Diaz Intermediates Corporation
Location Address	301 Wyanoke Road
City, State, ZIP code	West Memphis, Arkansas 72301
County	Crittenden
Direction/Orientation	East
Date	07/24/08
Time	0801
Photographer	Steve Cowan, Dynamac START-3
Witness	NA
Description: ERRS checking the integrity of the drum bungs in the South Pad area.

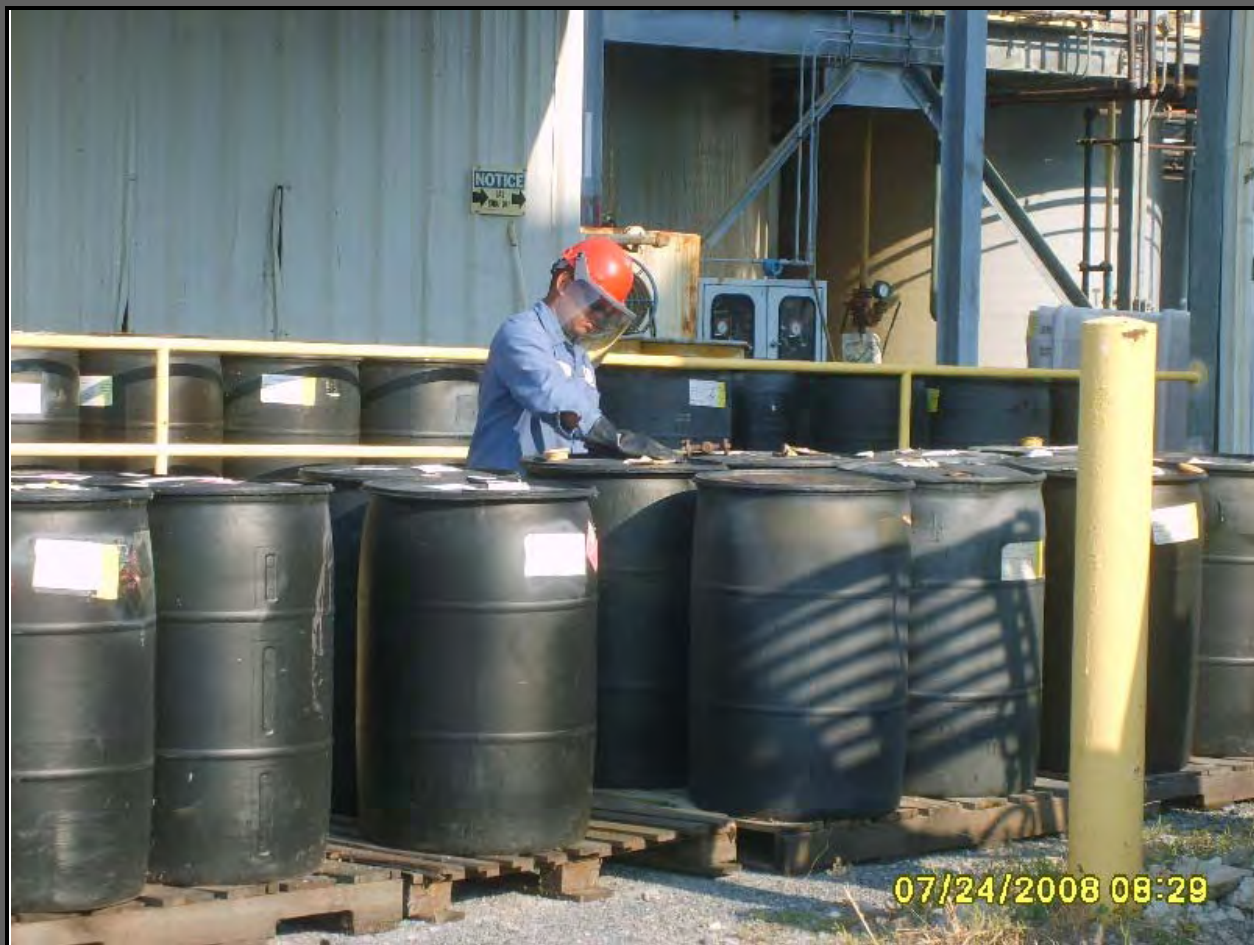
Logbook Photo #	131
US EPA ID / Task Order Number	ARR000005843 / TO-0001-08-01-01
Site	Diaz Intermediates Corporation
Location Address	301 Wyanoke Road
City, State, ZIP code	West Memphis, Arkansas 72301
County	Crittenden
Direction/Orientation	Northwest
Date	07/24/08
Time	0829
Photographer	Steve Cowan, Dynamac START-3
Witness	NA
Description:	ERRS checking the integrity of the drum bungs near Bulk Truck Loading area.

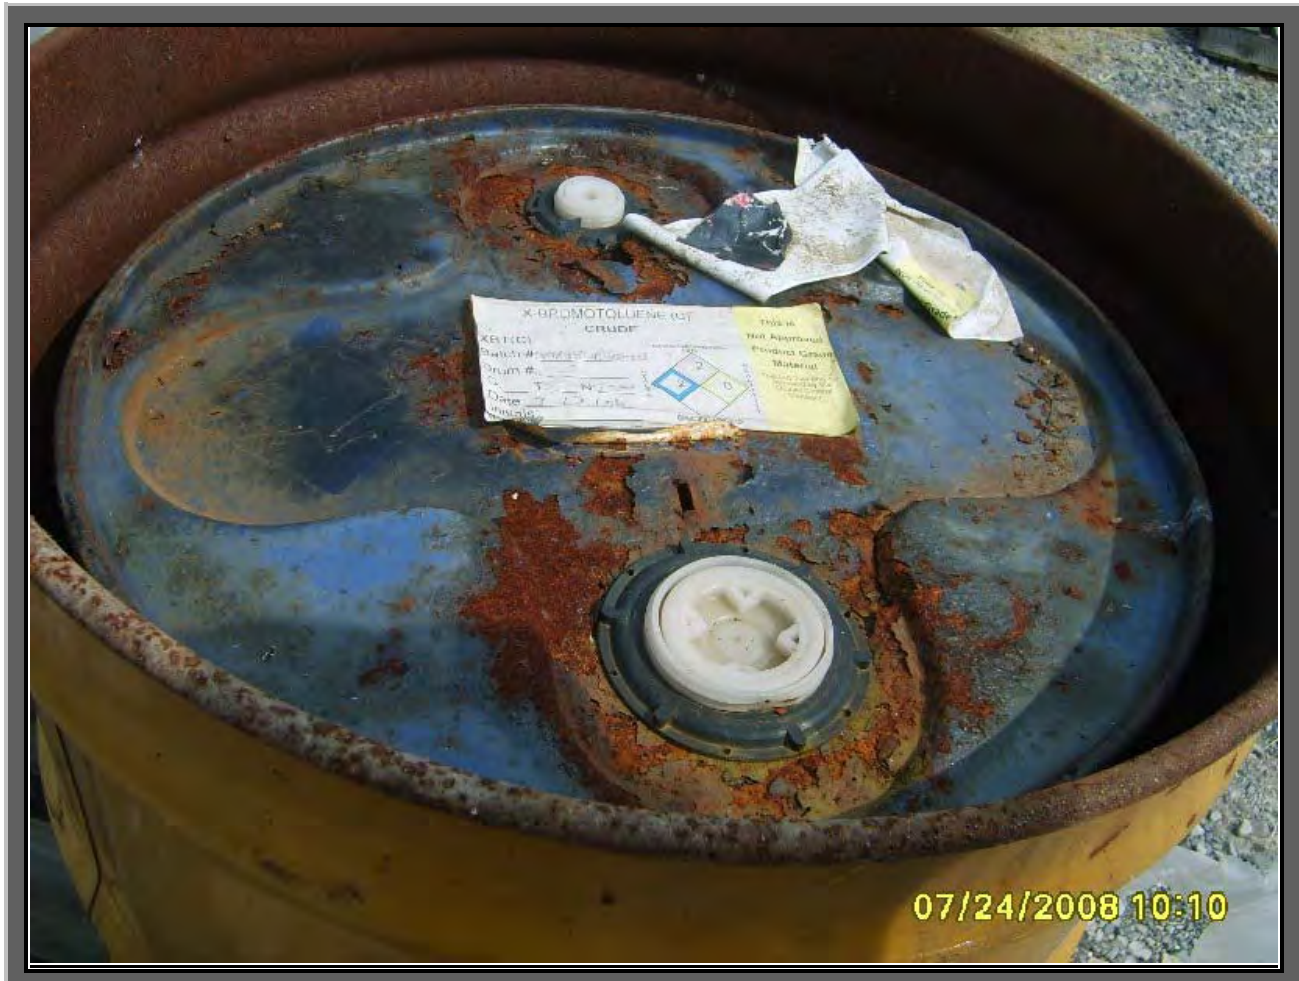
Logbook Photo #	132
US EPA ID / Task Order Number	ARR000005843 / TO-0001-08-01-01
Site	Diaz Intermediates Corporation
Location Address	301 Wyanoke Road
City, State, ZIP code	West Memphis, Arkansas 72301
County	Crittenden
Direction/Orientation	North
Date	07/24/08
Time	1010
Photographer	Steve Cowan, Dynamac START-3
Witness	NA
Description:	
View of corroded drum containing bromomethyltoluene (crude) inside salvage drum.
